Appendix A.

Reports of officers of the Geological Survey of India despatched to investigate the effects of the earthquake.

1. Report by Mr. T. D. LATOUCHE, *Superintendent, Geological Survey of India.*

CALCUTTA, ASSAM, SYLHET.

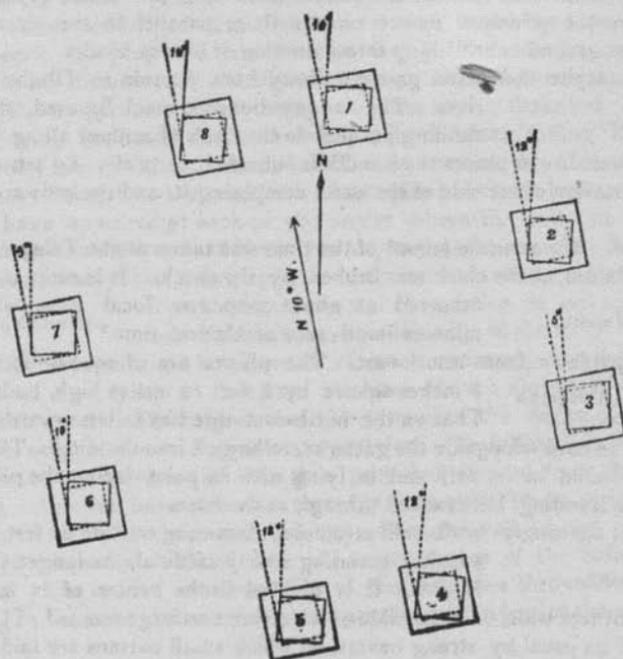
Fig. 24. Plan of pillars of thermometer shed at Dhubri.

up ported by eight brick pillars, each of which is cracked through near the base and twisted in the direction of the hands of a watch from 5 to 12 degrees.

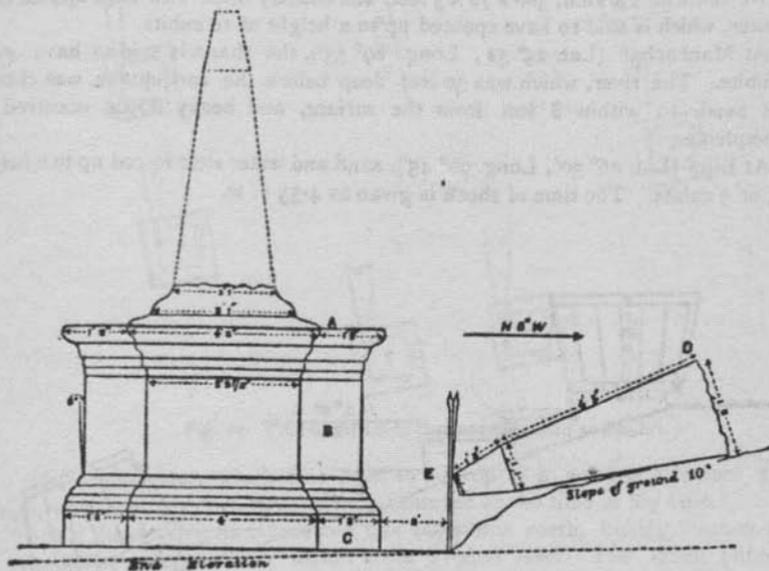
Fig. 26. Tomb of Ensign Law, Goalpara.

Ensign Law's tomb is of the same shape generally, but was surmounted by an obelisk 5 feet 8 inches high, which broke off at its plane of junction with the top of the tomb and was thrown to $N 5^{\circ} W$. As it fell, it must have

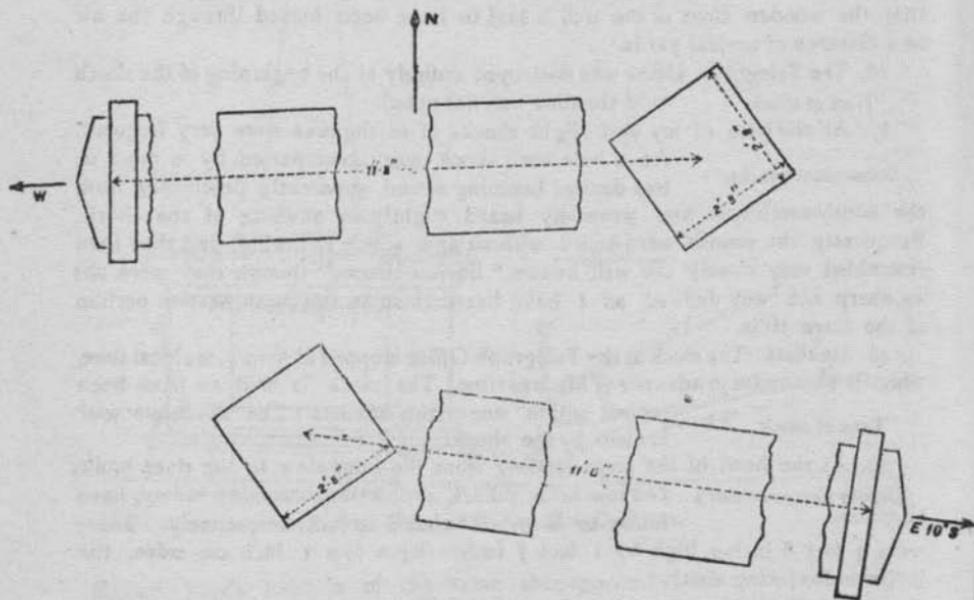
Fig. 27. Plan of overthrown gate pillars at Gauhati.

9 inches from the ground and twisted 6° , from $N 24^\circ W$ to $N 30^\circ W$. The other pillar is broken through at the same level but is not twisted.

At the gateway at the east end of this wall both pillars have fallen, one due west, the other to E 10° S (see fig. 27). At the western gateway there were similar pillars which have broken off at the height of the top of the wall, three feet from the ground, and fallen, one due N, the other to N 20° W.

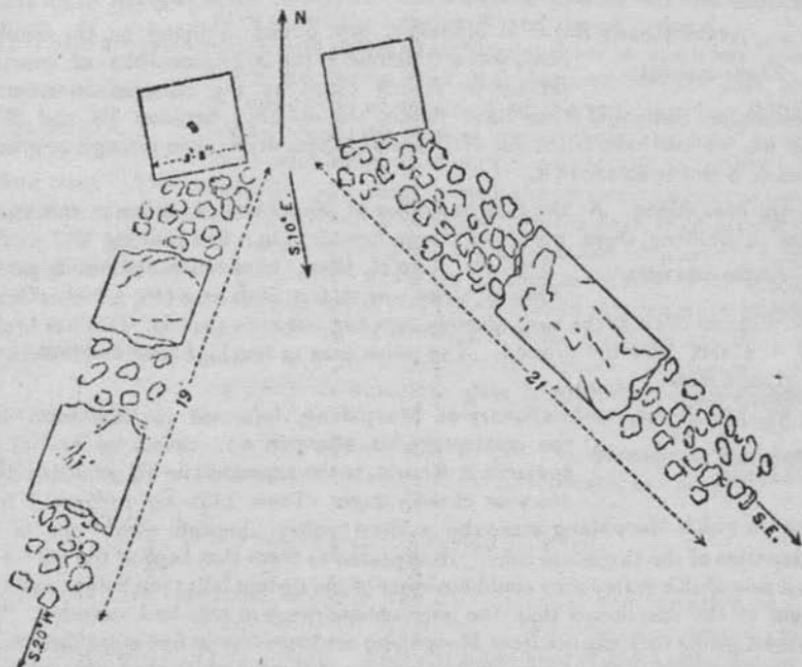
Fig. 28. Plan of overturned gate pillars at entrance to Inglis' house, Cherrapunji.

54. At the entrance to the avenue leading to Mr. Inglis' house stood two lofty Mr. Inglis' house gate gate pillars, which formed a conspicuous object in the land pillars. scape. No gates were attached to them. They were built of rubble stone masonry. Both have fallen, but in different directions, as shown in the plan, fig. 28. The material of one lies scattered to a distance of 19 feet from the base of the pillar, and the other to 21 feet.

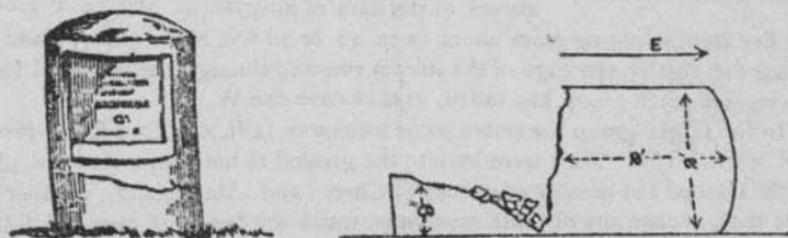
Fig. 29. Overturned tomb in Cemetery, Sylhet.

A low brick pillar, fig. 29, built of bricks rather loosely put together. The pillar broke across at about 9 inches from the ground and fell due east.

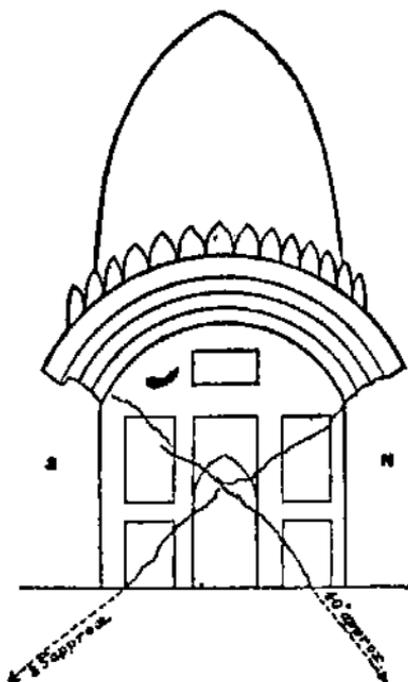
Fig. 30. Hindu Temple in cantonments, Sylhet.

A Hindu temple near the hospital, the four sides facing the cardinal points, has been cracked in a curious way as shown in fig. 30, the cracks running diagonally from corner to corner of the base. On the sides facing north and south a horizontal crack runs along at the top of the base beneath the dome. On the west side there is an arched door-

way and two cracks run diagonally upwards from the crown of the arch to the base of the dome. The wall surrounding the temple has fallen in the north and south sides, in each case to south, but is standing on the east and west.

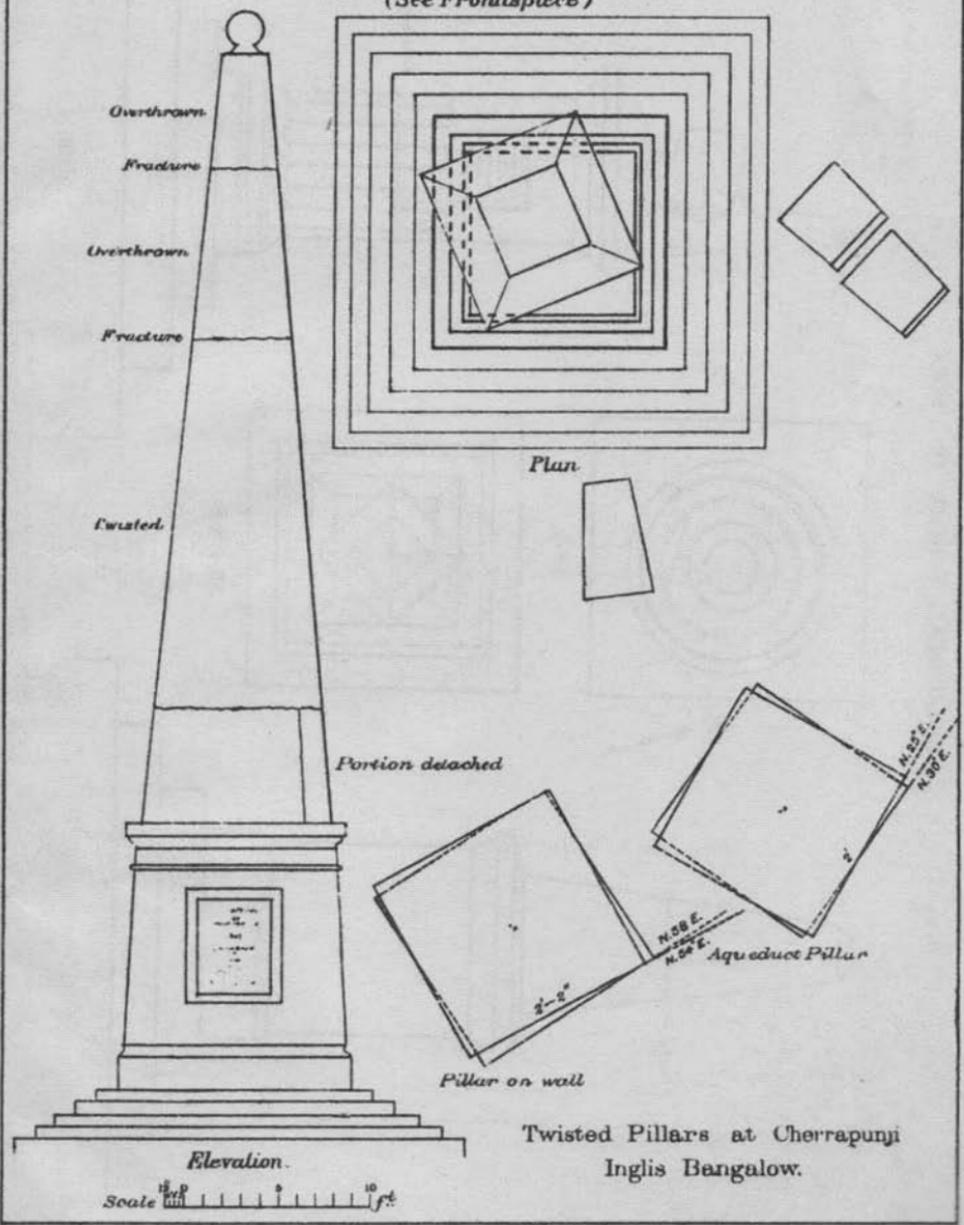
Twisted Pillars at Cherrapunji
Inglis Bangalow.

Close to the gateway of the house a small stream crosses the road, over which, when the house was inhabited, a small aqueduct was carried on a series of brick pillars. One of these on the edge of the stream has fallen, and the corresponding one on the other side has cracked across at the base and twisted through 5° from N 25° E to N 30° E. The pillars are built of brick.

At the gateway leading into the compound of the house an ornamental pillar standing on the wall surrounding the compound has broken across at the top of the wall and twisted through 5° from N 54° E to N 58° E. The height of the fracture from the ground is 4 feet 6 inches. The two gate pillars have fallen in a heap in the gateway, that on the east side having fallen to south-west. These pillars are built of rubble stone masonry.¹

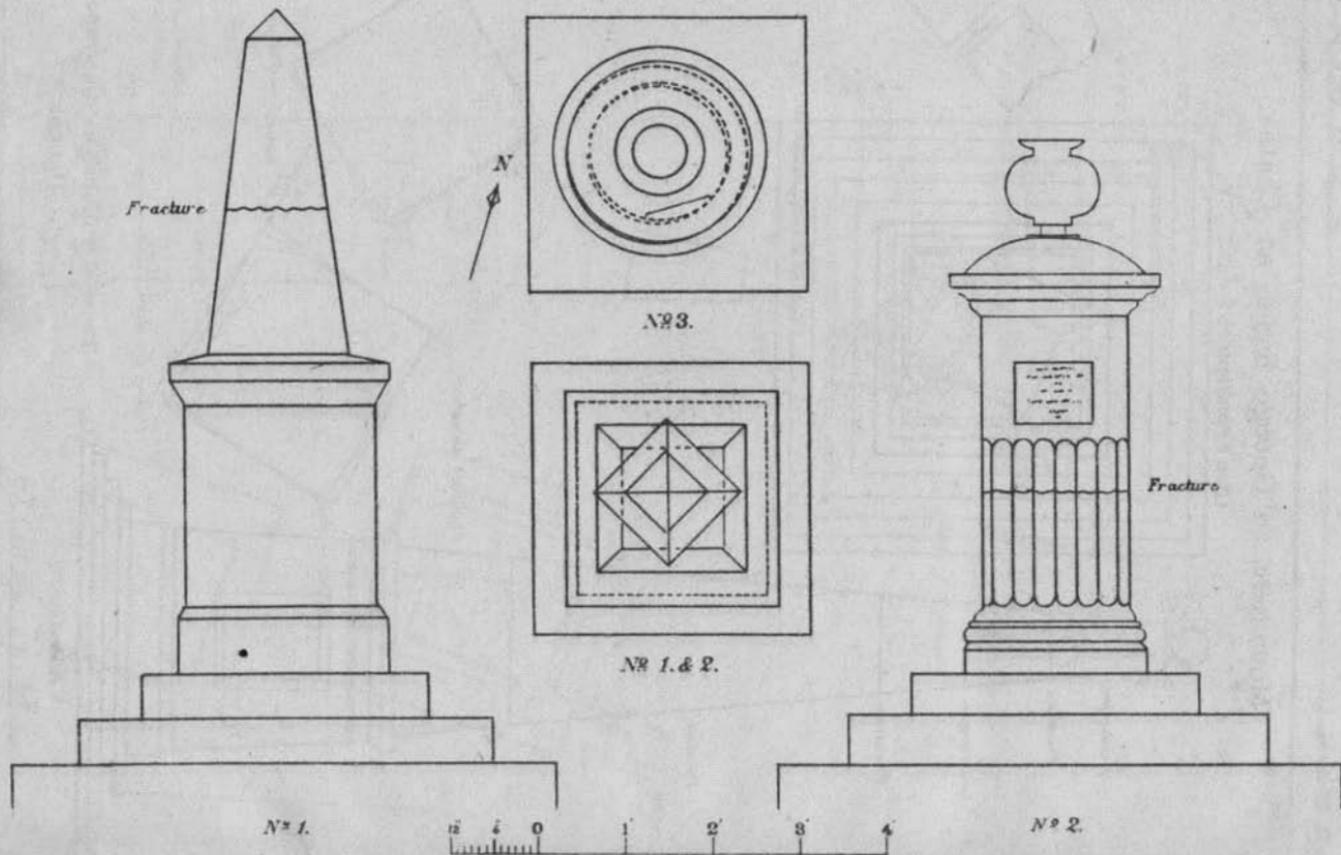
TOMBS IN OLD CEMETERY, GAUHATI.

25. Most of the tombs here are of the common square or oblong box shape built of brick masonry and plastered. That of G. T. Bayfield, died September 1840, was surmounted by an obelisk, the greater portion of which has fallen to S 20° E. A similar obelisk close by (F. Gomes, died September 1848), has fallen to S 25° E. The monument shown in Plate XXI, fig. 1, is of precisely similar construction, but in this case the obelisk is broken across at about half of its height, and the upper part has twisted 48°, from N 18° W to N 30° E. Close to this are two tombs standing on a common plinth and precisely similar in all respects, but instead of conical obelisks they were surmounted by cylindrical brick pillars 1 foot 6 inches in diameter and about 4 feet high. Of these one has fallen to N 45° W while the other has gone exactly at right angles to this, *viz.*, to S 45° W. Both pillars have been entirely broken up by the fall, but in the first case the base of the pillar is lying at a greater distance from the base of the tomb than the rest of the pillar. The tomb measures 3 feet square by 4 feet 6 inches high, and the base of the pillar is lying at a distance of 12 feet from the corner of the tomb nearest to it. The top of another obelisk (Samuel Fleming, died May 1853) has fallen to N 45° W. The lower part of the tomb on which this stands is also cracked through, at a height 1 foot 7 inches from the plinth. This tomb measures 4 feet 9 inches high by 2 feet 9 inches square.
