News Release News Release News Release News Release News Release

**Pre-1950 structures suffered the most damage from August 2014 Napa quake,
according to study published in *Seismological Research Letters (SRL)***

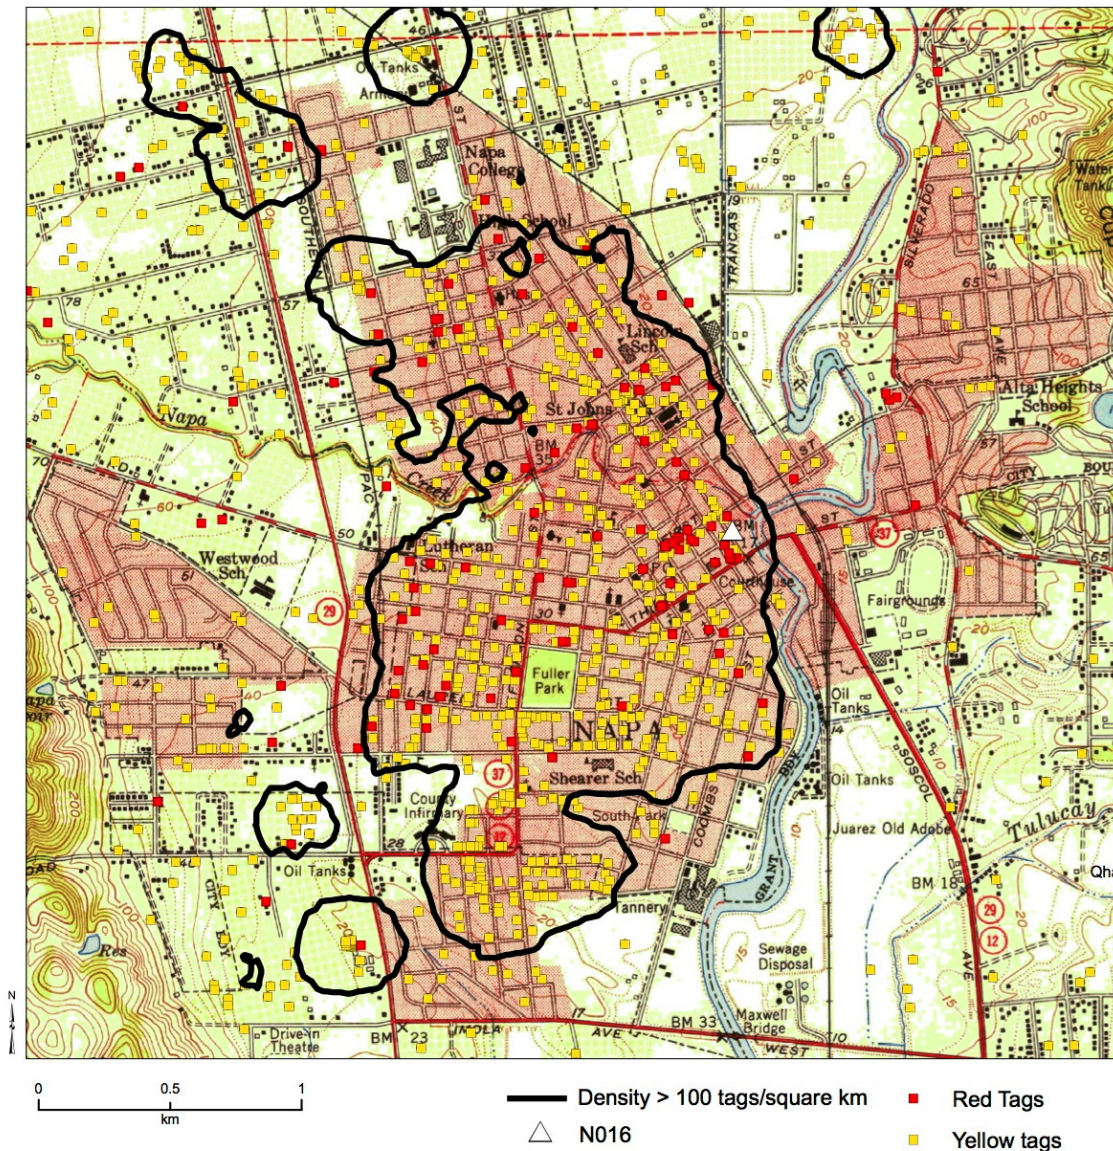
▲ **Figure 1** (Boatwright *et al.*) Red and yellow tags plotted on the street grid and topography of Napa. Fault traces are drawn as black lines. Note the five red tags aligned on the fault in Brown’s Valley. The dark line running north–south through central Napa is State Route 29. The Napa River is not marked. The brown contours show tagging densities $>100/\text{km}^2$. The largest concentration of tags is located in central Napa.

Boatwright *et al.*, analyzed data provided by structural engineers who inspected and tagged damaged buildings after the earthquake. The 165 red tags (prohibited access) and

1,707 yellow tags (restricted access) stretched across the city but were primarily concentrated within the residential section that lies between State Route 29 and the Napa River, including the historic downtown area.

When comparing the distribution of red and yellow-tagged buildings to the underlying sedimentary basin, to the pre-1950 development of Napa and to the recent alluvial geology of Napa Valley, the most severe damage correlates to the age of the buildings—pre-1950 construction—and their location within the basin. Less damaged areas to the east and west of central Napa lie outside of the sedimentary basin, and the moderately damaged neighborhoods to the north lie inside the basin but are of more recent construction.
