Appendix A.

Reports of officers of the Geological Survey of India despatched to investigate the effects of the earthquake.

1. Report by Mr. T. D. LATOUCHE, *Superintendent, Geological Survey of India.*

CALCUTTA, ASSAM, SYLHET.

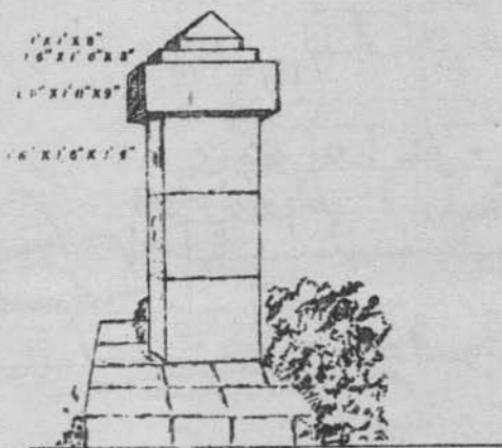
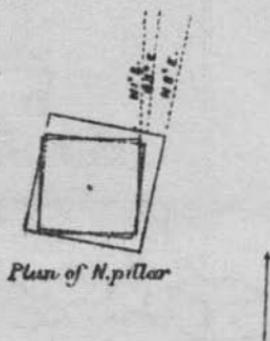
Fig. 1.

S. pillar fallen due N.

Plan of N. pillar

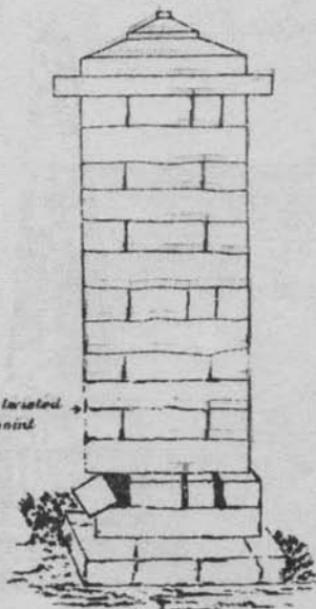
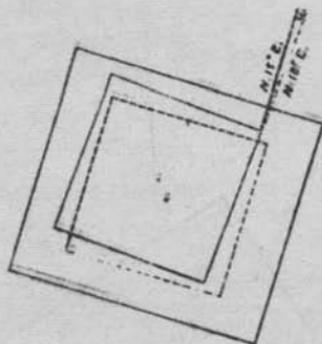
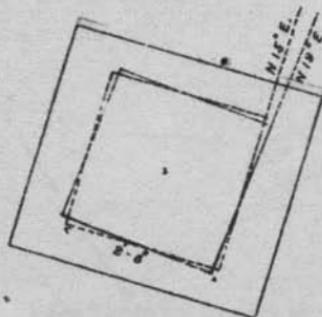
Fig. 2

Western pillar

Eastern pillar

Monument to George Inglis at Chatak.

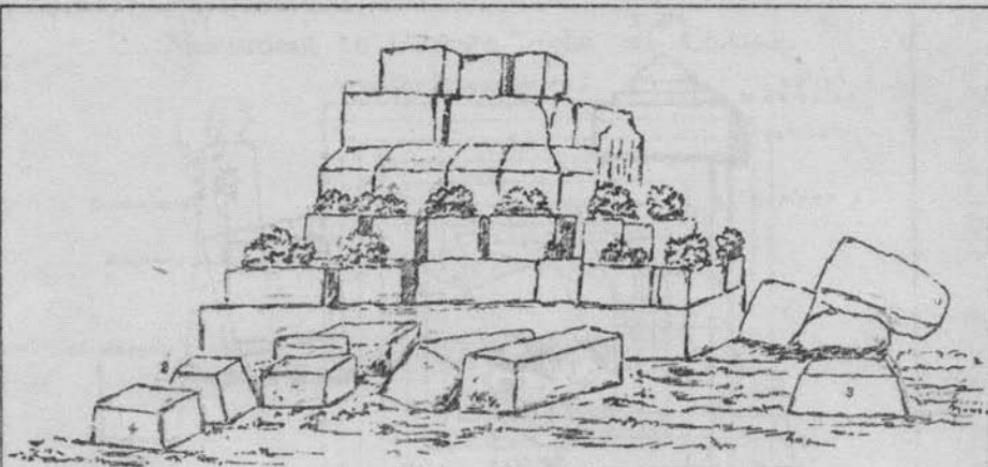
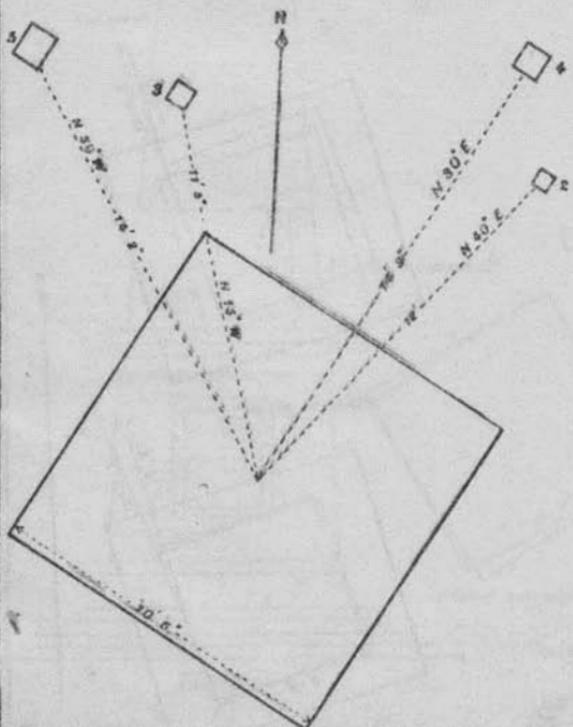
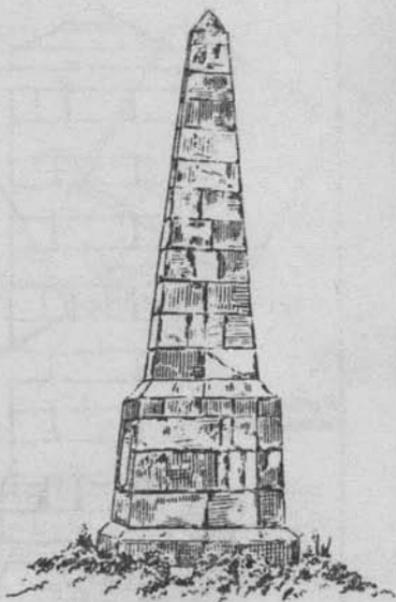
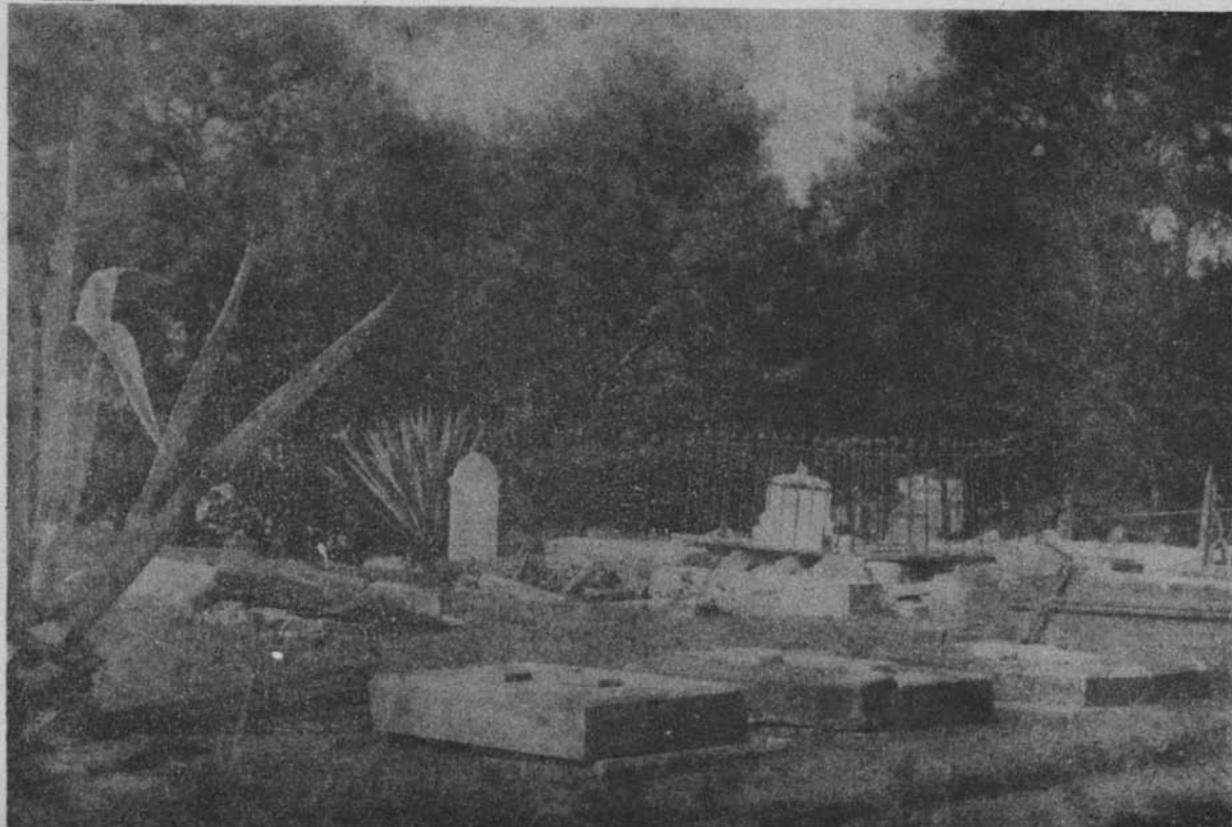
TOMBS IN OLD CEMETERY, GAUHATI.

From N side

Plan showing position of 2nd, 3rd, 4th and 5th blocks from top of obelisk.

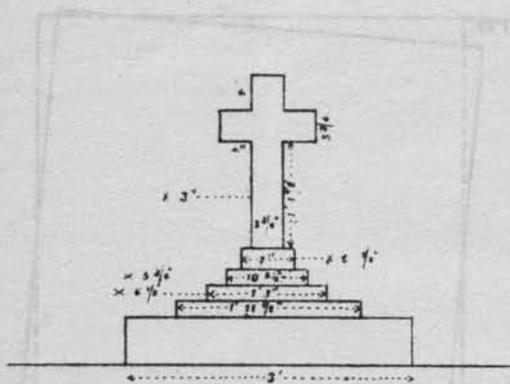
Fig. 1.

- R. D. Prazer, d. June 1884.
Pl. XXXVIII, fig. 1. In this case the marble slab carries a small marble cross, supported on three steps near the west end. The cross has not fallen, but the west end of the slab supporting it has been jerked to the south, being twisted through an angle of 15°.

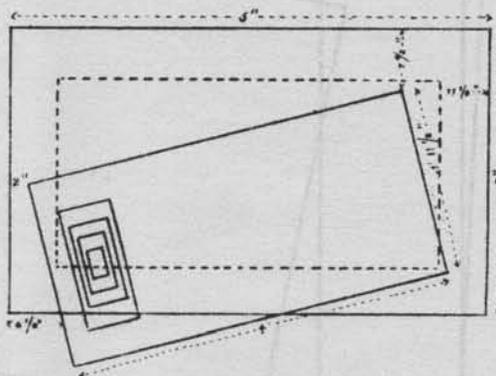
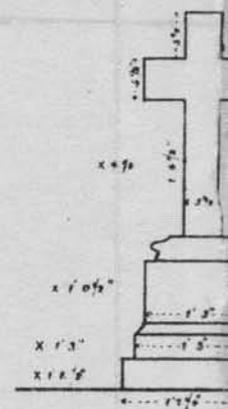
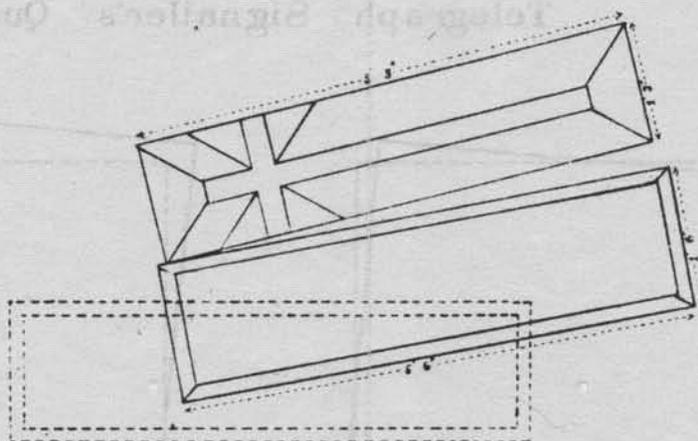
Fig. 3.

- Mrs. Sherriff, d. August 1881.
Pl. XXXVIII, fig. 3. This is a similar tomb to the last, but in this case both slabs have been jerked to the north-east. The upper one then slid off and is lying beside the lower.

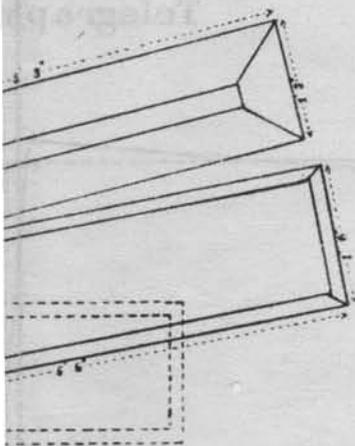
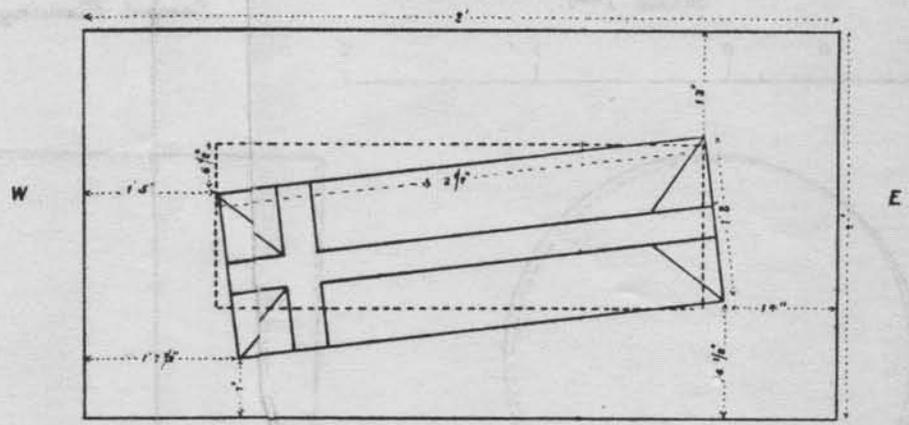
Fig. 4.

- Mrs. McCulloch.
Pl. XXXVIII, fig. 4. A marble slab with cross carved upon it, resting on a quartzite plinth. The western end of the stone has been jerked round to S, while the eastern end has hardly moved.

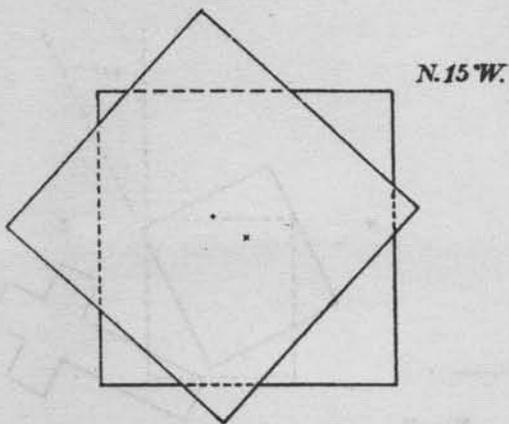
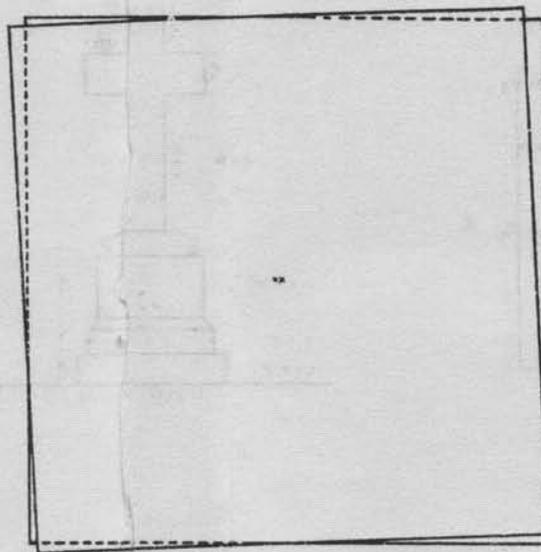
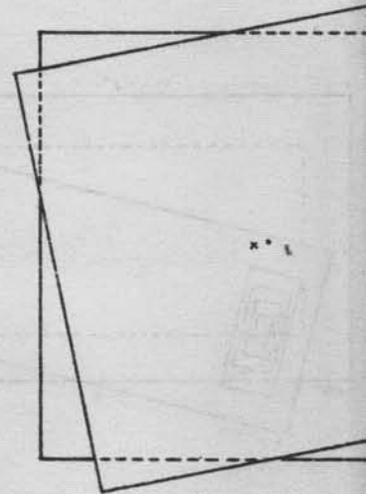
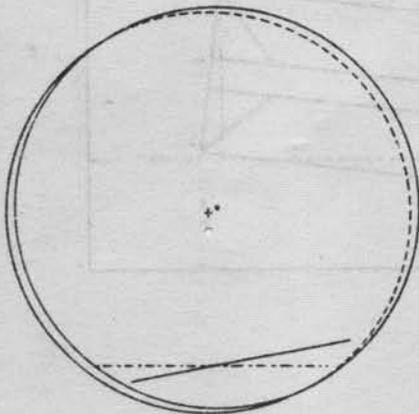
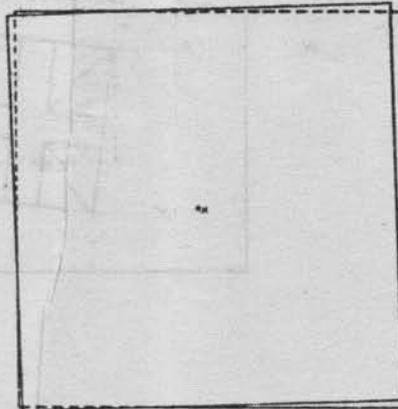
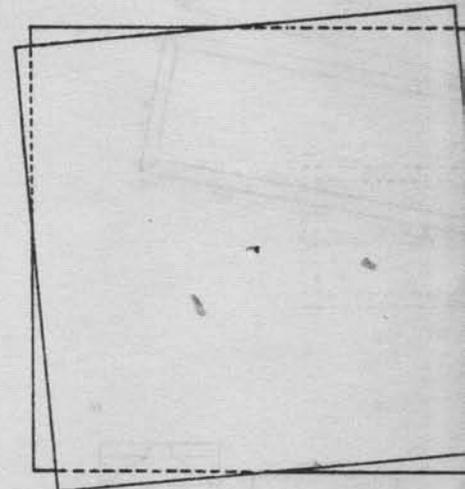
Judge's Compound.
N. Gate Pillar.

East Pillar.

N. 15° W
